Manhole Inspection Summary

Manhole # S330__012MH

Insp Date: **3/19/08 10:25 AM**

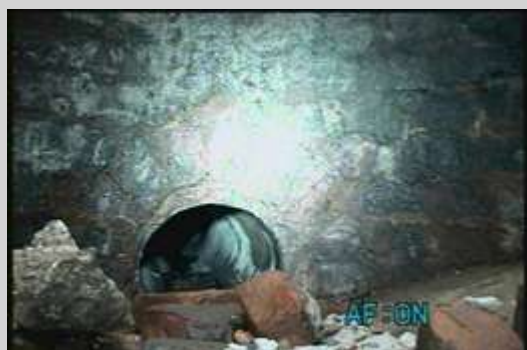
12 O'Clock Outflow

8 in. Circular Gravity Sewer
Pipe Out @ 12 O'Clock

Infiltration: **None** Pipe Seal Cond: **Unknown**
